Failure Analysis of Selected Fasteners Used During World War II

by:
Charles C. Roberts, Jr.
ccr@robertsarmory.com

This article deals with fasteners used on military vehicles to connect track sections during World War II. Tank track fasteners were a problem in World War II. The ideal fastener would connect tank track sections together, allowing flexibility of the sections as they traveled around the drive sprocket and idler wheel. The ideal fastener would allow for tight track adjustment to avoid throwing a track and have minimal wear. The following are selected examples of track section fastener applications during World War II.

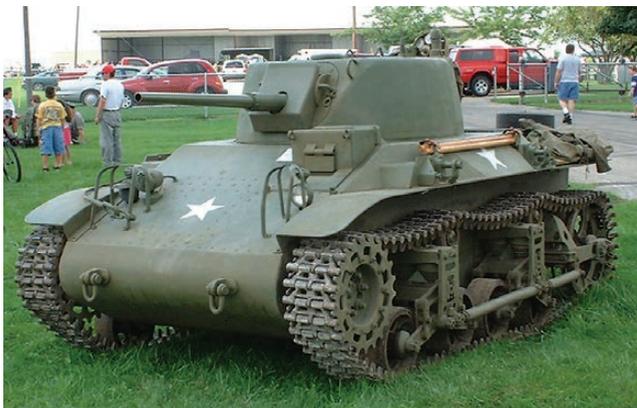
Figure 1A is a view of a 1943 M22 light tank with Cardon-Loyd designed track.

Fig. 1A — U.S. M22 light tank 1943.

Wear of the fastener was also a problem. Severe wear would occur from road dust and sand, causing the holes in the track section to elongate and the track pins to decrease in diameter as shown in **Figure 1E**. A tight track tension caused the highest wear rate, so track tension was reduced as shown by the track sag in **Figure 1A**. This increased the chance of

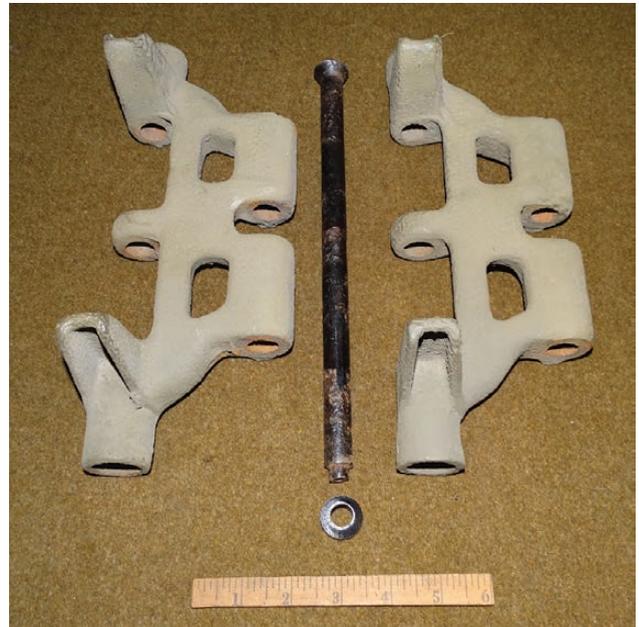
Figure 1B is a view of the dry pin track fastener that connects the tracks on this vehicle. There were two drive sprockets contacting the outer round surfaces of the track sections. The round retainer at the bottom middle in **Figure 1B** is placed on the connector shoulder and staked into position using a punch die that spreads the steel shoulder and secures the circular retainer as shown in **Figures 1C** and **Figure 1D**.

Fig. 1B — Two Cardon-Loyd track sections with pin and retainer.

To remove the track fastener or connector, one has to drive it out using a sledge and special tool to shear off the circular retainer. A new fastener is required to reassemble the track. The hardness of the track pin was approximately 25 RC. There was variability in track retention because skill was required to install the track pin. The circular retainer had to be properly secured by the deformation to the shoulder of the track pin

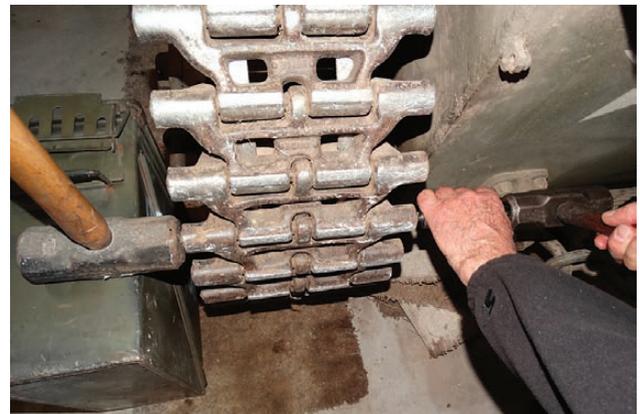
Fig. 1C — Staking the retainer onto the track pin.

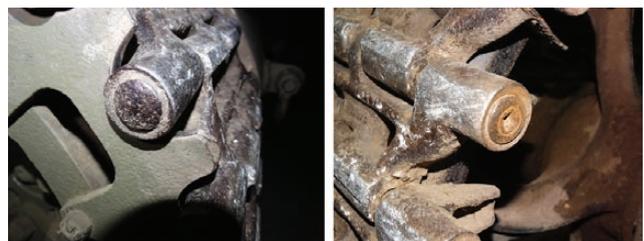
Fig. 1D — View of pin head end and staked end.

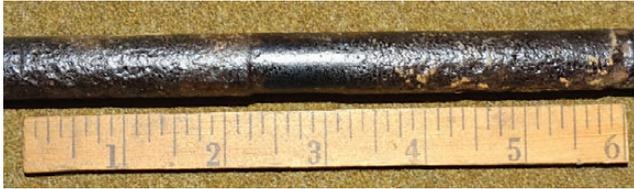
throwing a track under certain conditions. It should be noted that at each connection, the track pin would rust in and not allow pivoting, while the neighboring track section would pivot on the track pin. That explains the severe pitting on one part of the pin as well as the smooth wearing on the other in **Figure 1E**. Failure modes included severe wear and throwing of a track from lack of track tension.

Fig. 1E — Wear pattern in the center with pitting corrosion to the left and right.

This fastener design was deficient in that skill was required to properly deform the retainer, resulting in unreliability and severe wear from easy dirt entry into the track pin bearing surfaces.

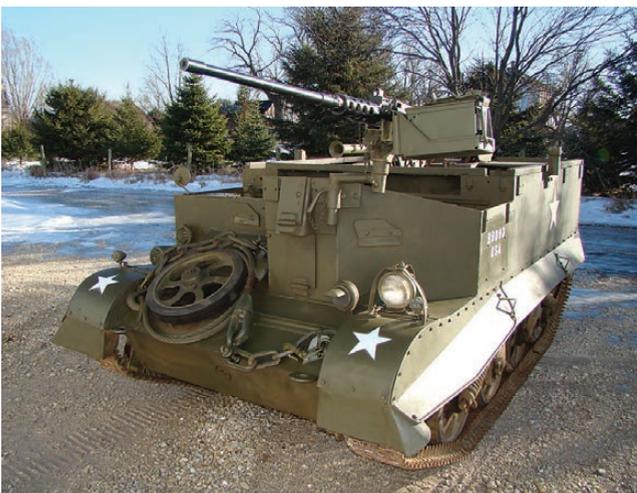
Figure 2A is a view of a T16 carrier used by the British in World War II. **Figure 2B** shows the tracks sections used in this vehicle. This track utilized a single sprocket design that engaged the track in the center. Track pin connectors had a donut-style retainer that was held in position by a roll pin. The retainer worked well, but as with many dry pin designs, severe wear resulted as shown in **Figure 2C**. Again, rust secures the pin on one track section, but allows rotation on the neighboring track section. There is also evidence of bending deformation from the center drive sprocket as the pin and track sections wear. **Figure 2D** shows track twist from wear and bending deformation of track pins. Failure modes for this pin design were severe wear and bending, resulting in track twist.

Fig. 2A — British T16 carrier.

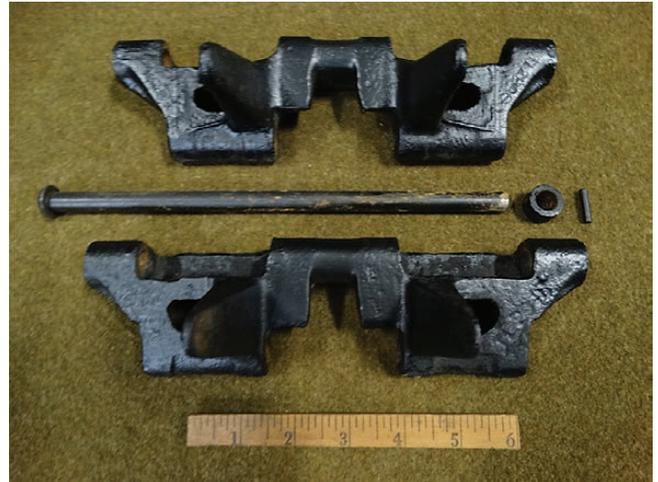
Fig. 2B — Two track sections with pin, donut retainer and roll pin.

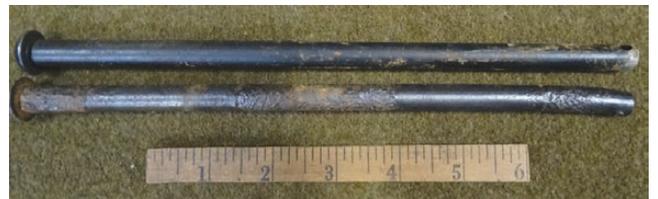
Fig. 2C — New upper pin and used lower pin showing wear and pitting corrosion patterns.

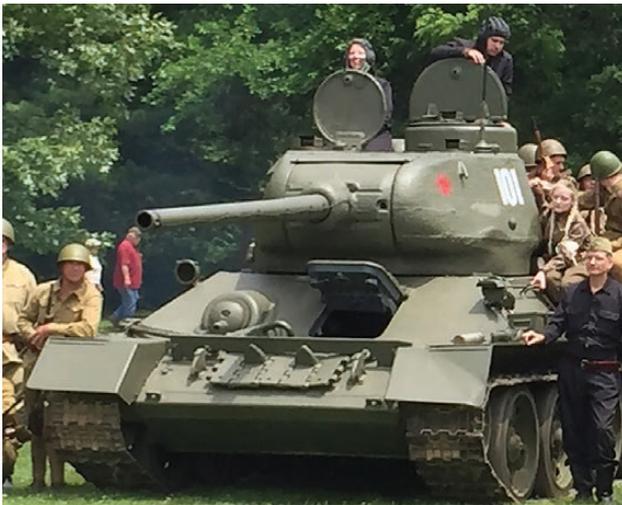
Figure 3A is a photo of a Russian T34 tank which was manufactured by the thousands in WWII. Like many tanks of that era, it utilized a pin to connect the tracks. This was an unusual design in that the track pin did not have a retainer. It was a floating pin inserted from the inside of the track to the

Fig. 3A — Russian T34 medium tank.

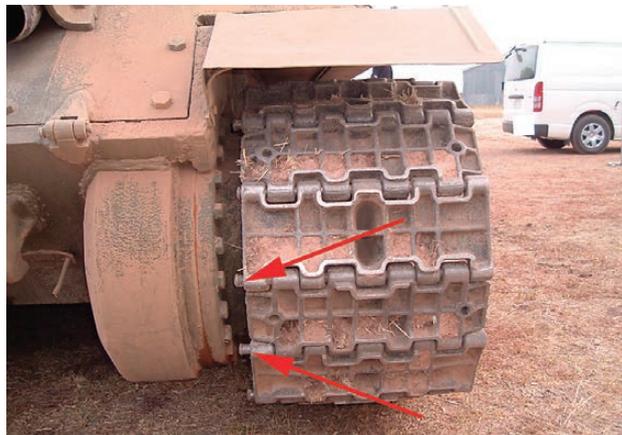
outside (**Figure 3B**). It had a round head at one end to prevent the pin from working its way outboard. The design was such that the pin would float toward the inside, but be pressed back into position as the tracks turned, by a shoulder welded to the hull as shown in **Figure 3C**. This apparently worked, but was noisy as the pins were getting smacked back into position. This tended to increase wear since it added translation

Fig. 3B — Track pins working out of position in a T34 (courtesy of Doug's Heavy Metal Gallery).

movement to the pin as well as the normal rotary movement of the track pin. Long-term reliability of such a system is in doubt, but the expected life of such a vehicle in WWII was on the order of days. Also there was the danger of a loose pin working out quickly while the vehicle was moving slowly and engaging on some other location on the hull. This design was inexpensive but suffered from excessive wear and the likely pin interference and fracture when the pin engaged the hull

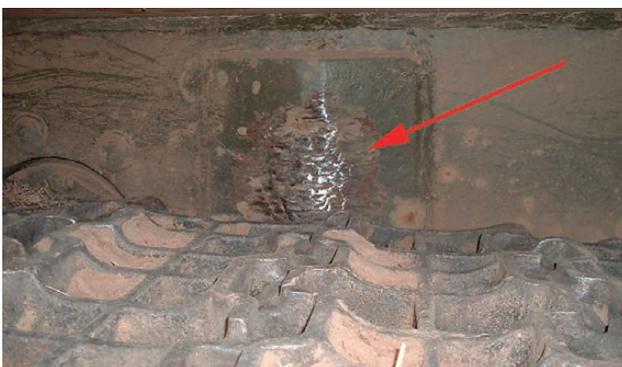
Fig. 3C — Track pin shoulder pin relocator welded on the side of the hull (courtesy of Doug's Heavy Metal Gallery).

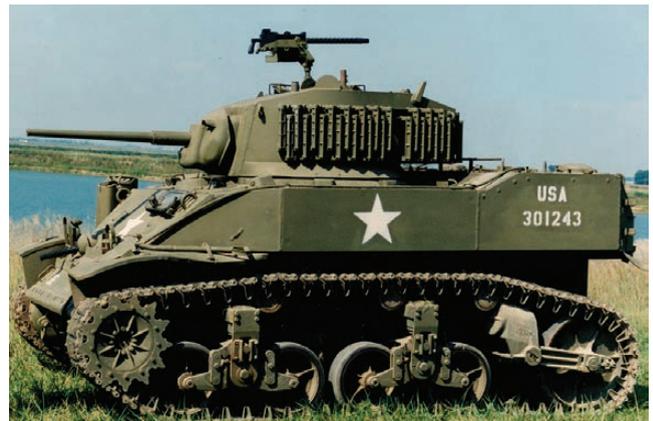
Figure 4A is a photo of the U.S. light tank M5A1 which used rubber block track sections. The steel tracks that have been shown previously tended to damage paved road surfaces. The rubber block tracks do not and are very quiet. The track pins are pressed into the track block with rubber bushings around the pins as shown in **Figure 4B**. A track guide and connector was pressed into the track pin, seen in **Figure 4C**. A “T” wedge fastener is inserted in the connector and the lock nut tightened so the track blocks are secured as shown in **Figure 4C**. Movement of the track sections relative to each other is allowed by the rubber bushings that surround the track pins. This movement is limited, but the drive sprocket and idler wheel are large as shown in **Figure 4A** and the limited relative movement of the track sections is easily accommodated.

Fig. 4A — M5A1 light tank.

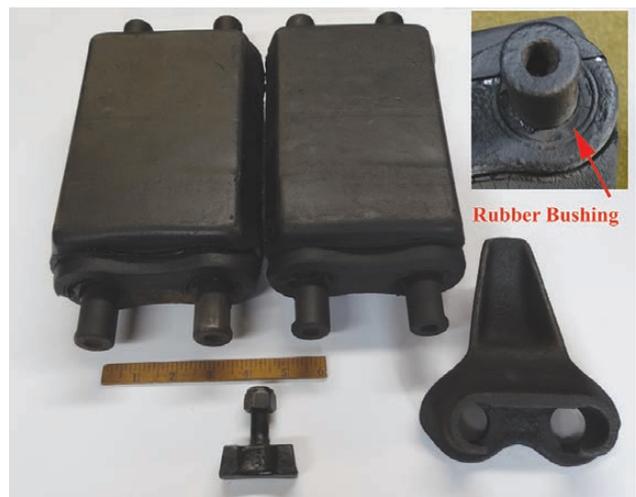
Fig. 4B — Two track sections, connector guide and wedge lock fastener.

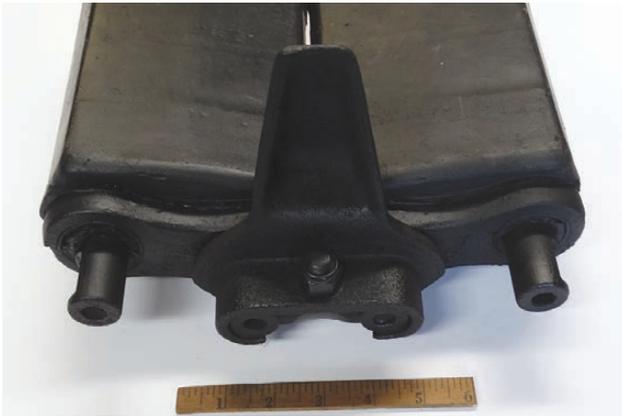
Fig. 4C — Track guide and connector was pressed into the track pin.
